<b>HYUNDAI</b> <b>Technical Service Bulletin</b>	<b>GROUP</b> <b>RECALL</b>	<b>NUMBER</b> <b>18-01-005</b>
	<b>DATE</b> <b>JANUARY, 2018</b>	<b>MODEL(S)</b> <b>Elantra (MD/UD)</b> <b>Elantra Coupe (JK)</b> <b>Elantra GT (GD)</b>
<b>SUBJECT:</b> 2013-2014 ELANTRA (MD/UD, JK, GD) BRAKE PEDAL STOPPER REPLACEMENT (RECALL CAMPAIGN 170)

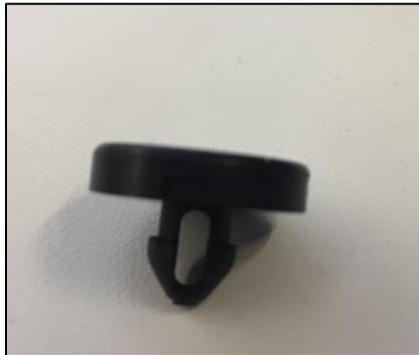
**Description:** The brake pedal stopper pad is located between the stop lamp switch and the brake pedal arm. The brake pedal stopper pad material in the affected vehicles can deteriorate allowing the stop lamp switch plunger to remain extended when the brake pedal is released. A deteriorated pad can result in the stop lamps illuminating continuously, illumination of the traction control warning lamp, the ability to move the shift lever without depressing the brake pedal, or activation of the engine management system's brake pedal override feature.

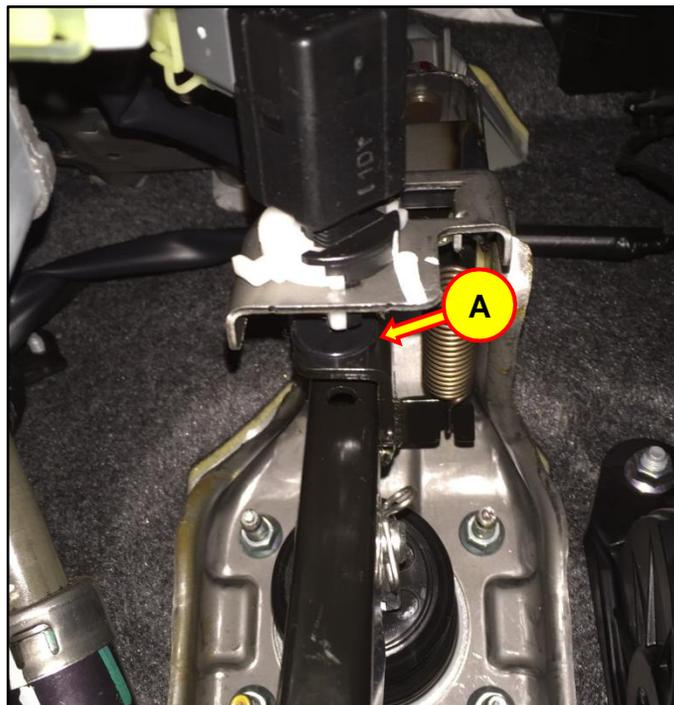
4. The stopper (A) is mounted on the brake pedal, in-line with the stop lamp switch.
